**TRANSPORTATION SCIENCES CENTER
ACCIDENT RESEARCH GROUP**

CALSPAN CASE NO. CA94-31

**VEHICLE #1 - 1992 TOYOTA CAMRY LE
DRIVER SIDE AIR BAG
DRIVER FATALITY**

ON-SITE INVESTIGATION

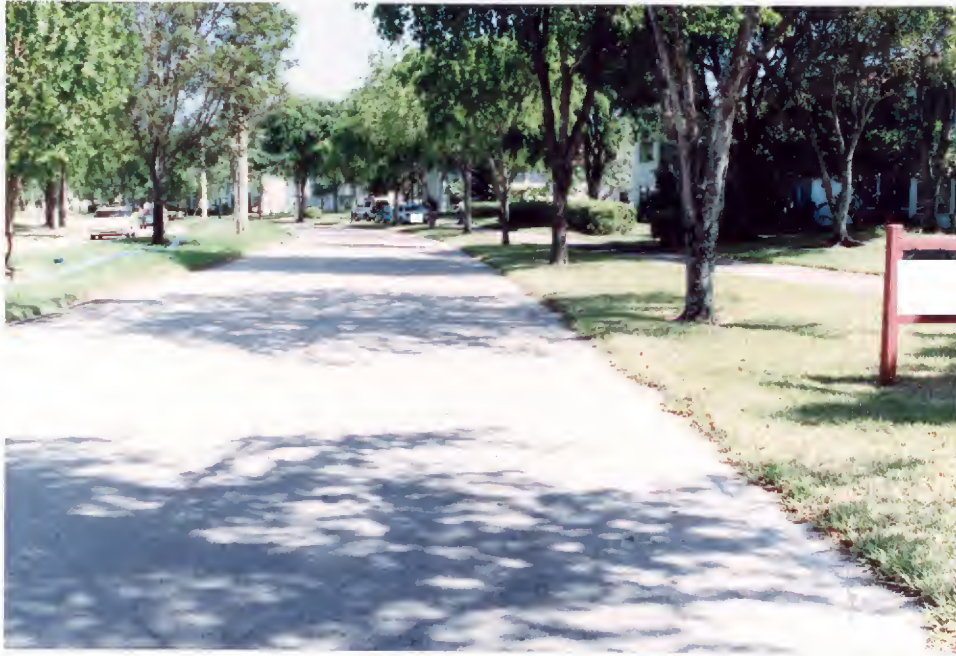
1. Trajectory of Vehicle #1, 1992 Toyota Camry LE, 90 m (300') west of the point of impact (POI).

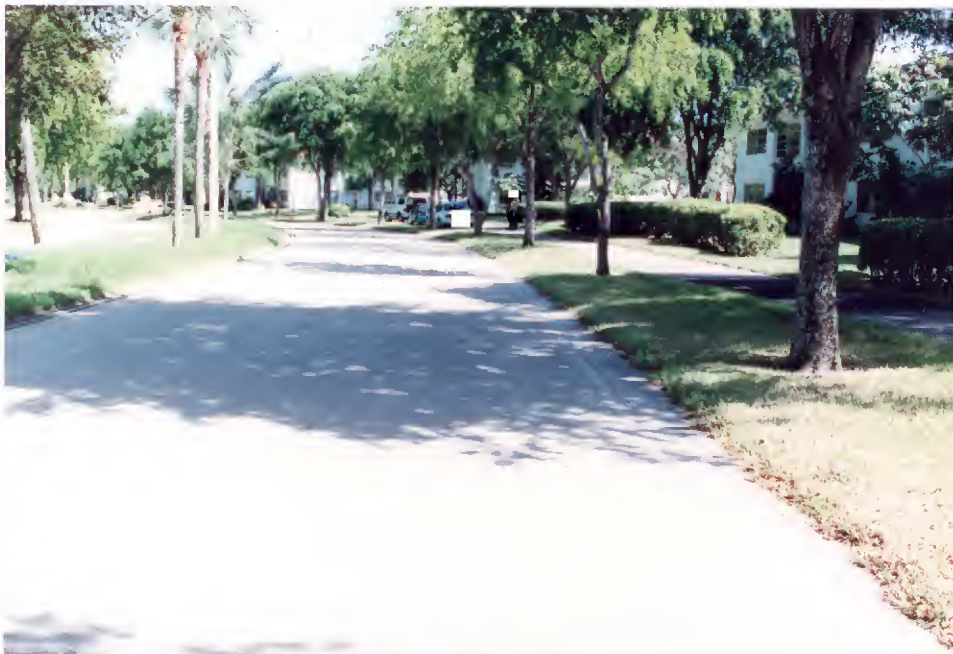
2. Trajectory of Vehicle #1, 75 m (250') from the POI.

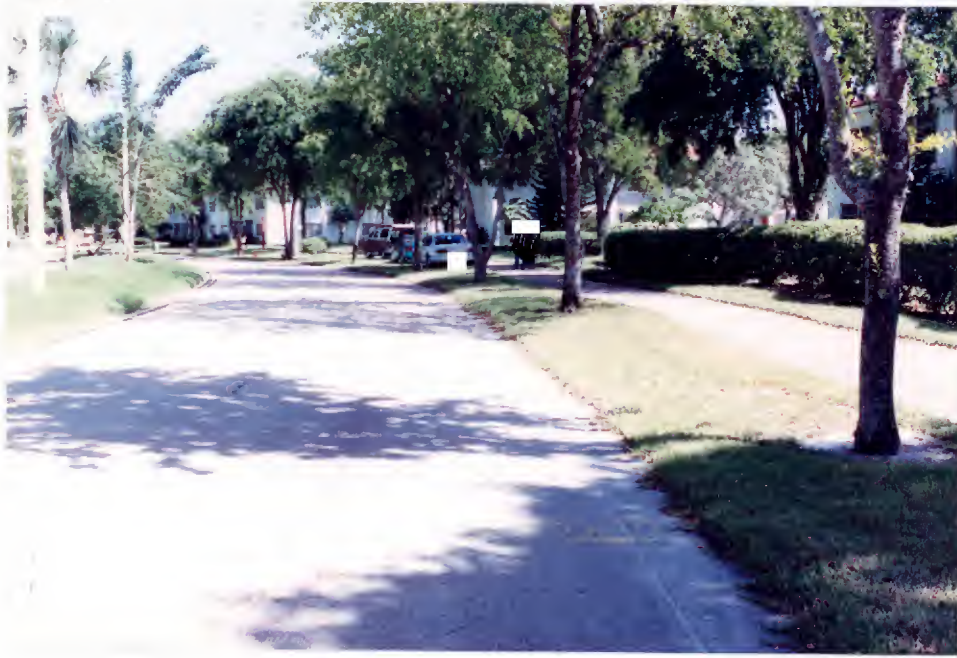
3. Trajectory of Vehicle #1, 60 m (200') from the POI.

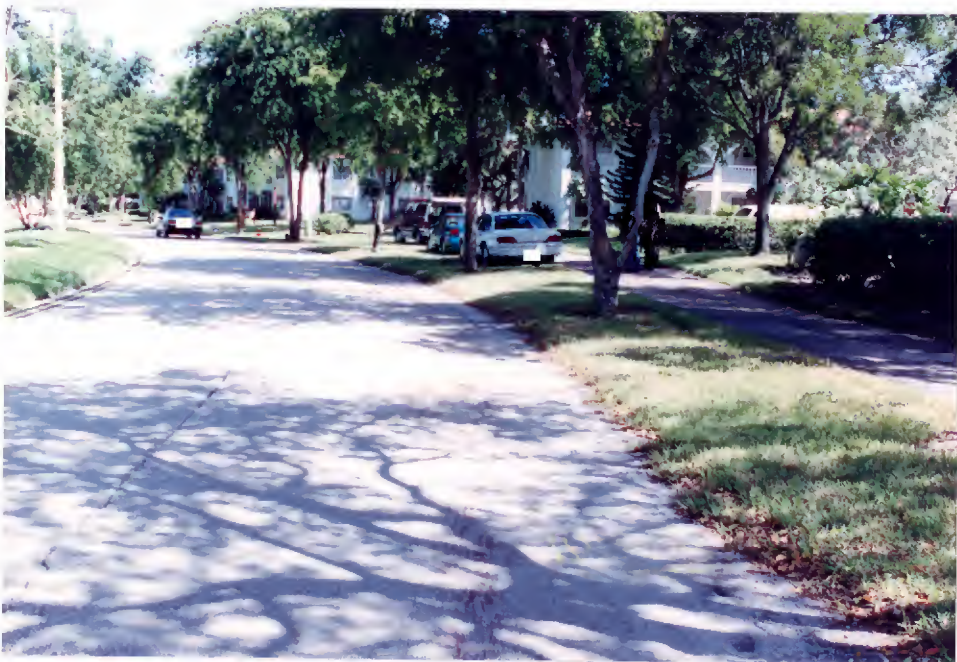
4. Trajectory of Vehicle #1, 45 m (150') from the POI.

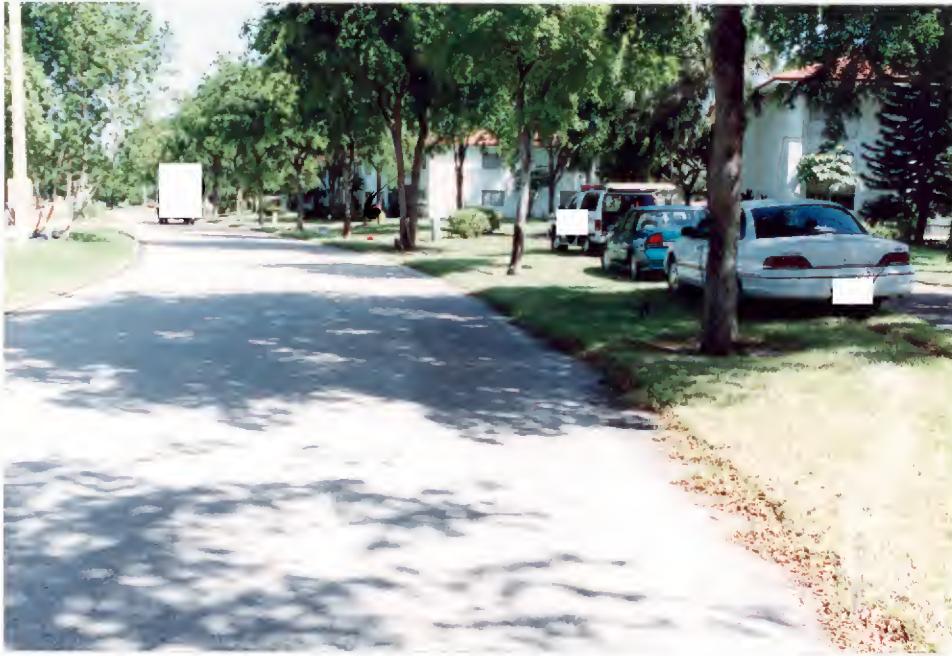
5. Trajectory of Vehicle #1, 30 m (100') from the POI.

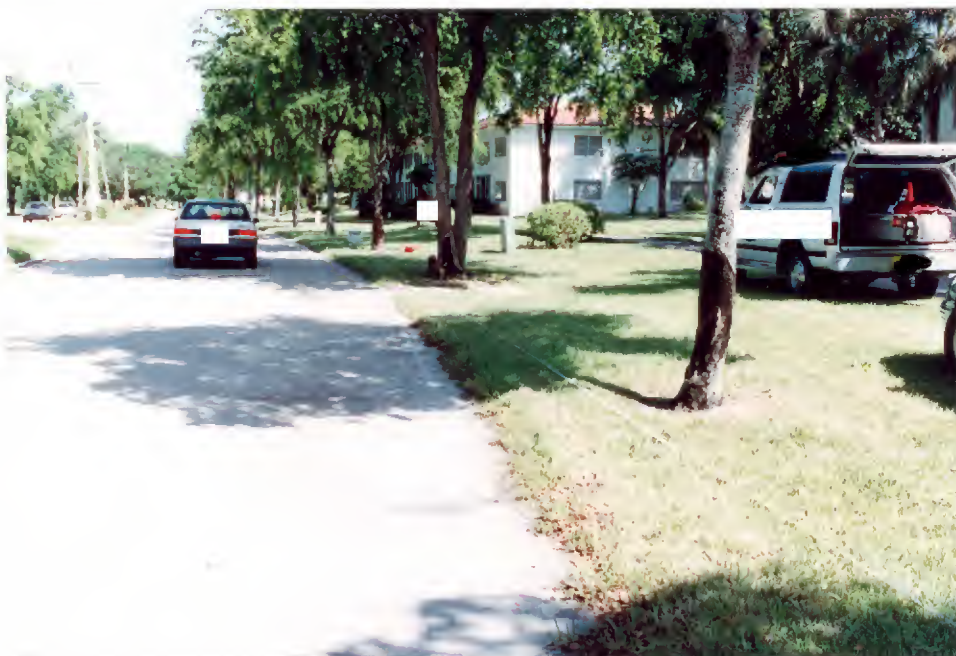
6. Trajectory of Vehicle #1, 15 m (50') from the POI.

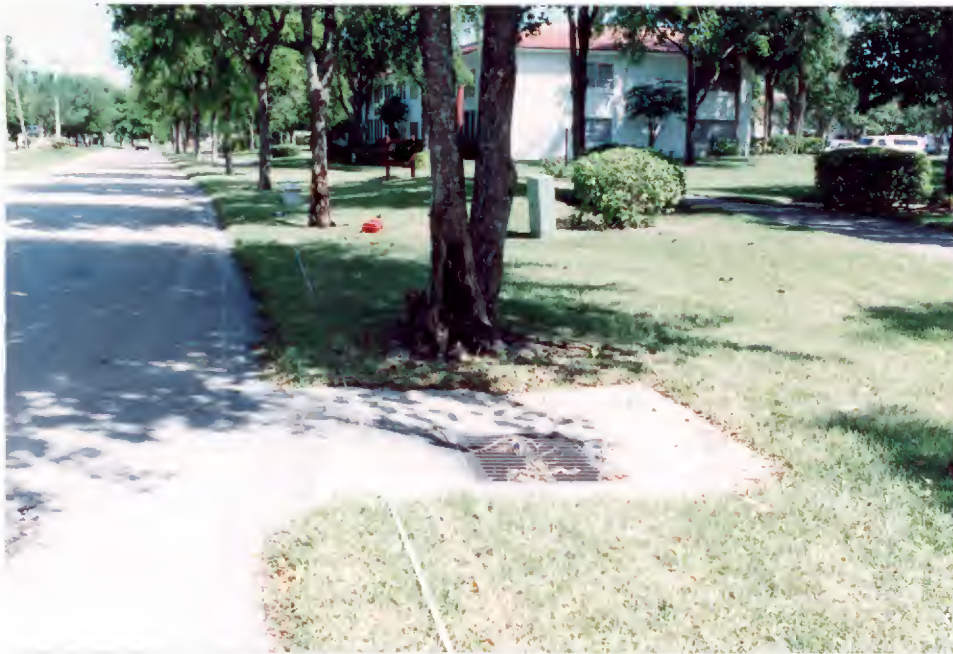
7. Trajectory of Vehicle #1, 3 m (10') from the POI.

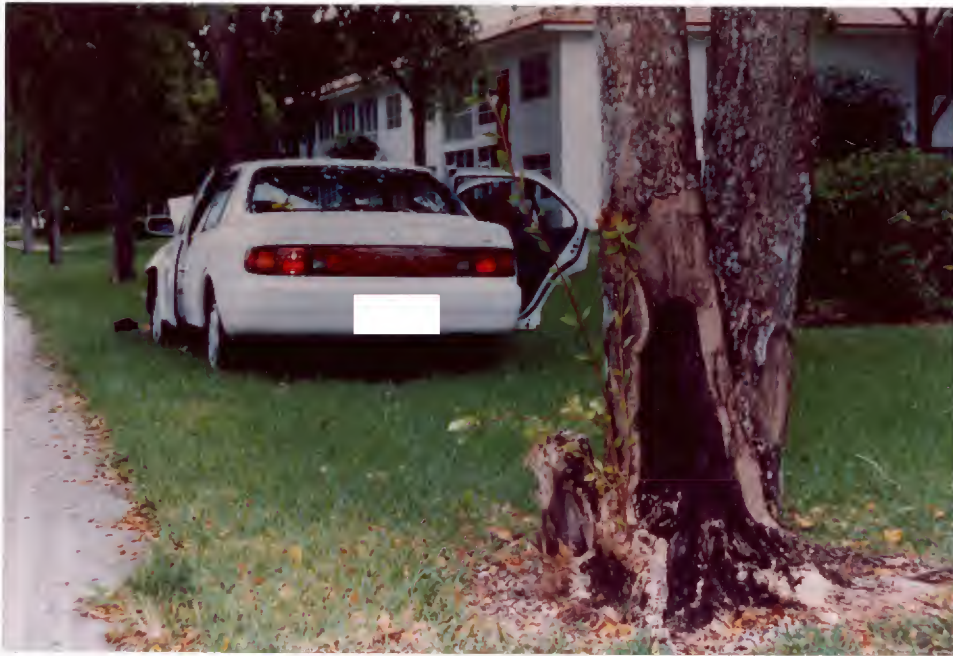
9. On-scene photograph of Vehicle #1 10.5 m (35') prior to the impact with the second tree.

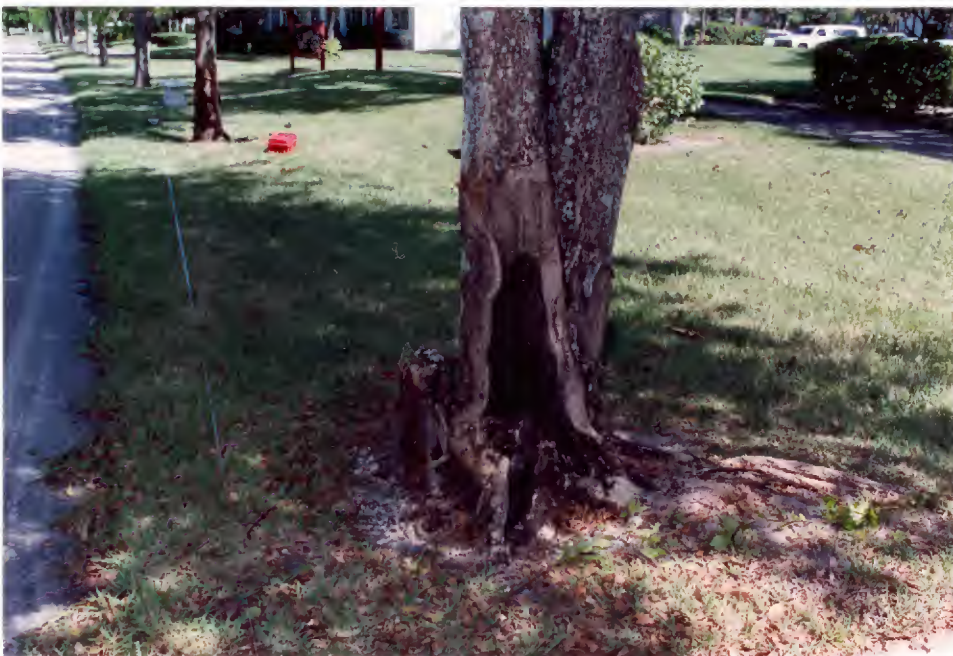
10. Same view as Photograph #9. taken during the follow-on investigation.

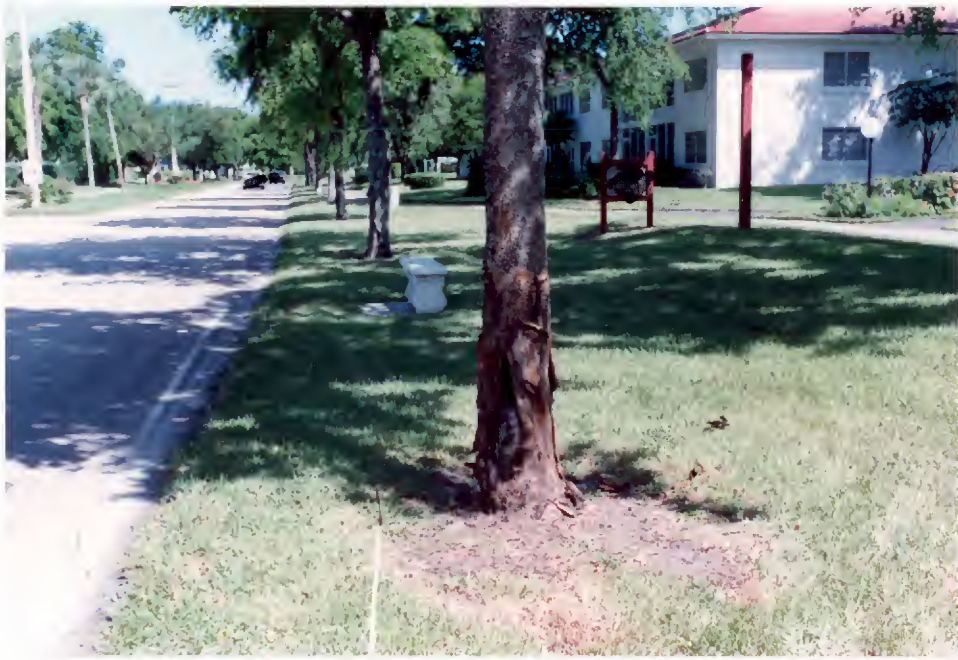
11. Post impact trajectory 2.1 m (7.0') prior to the vehicle's impact with the second tree.

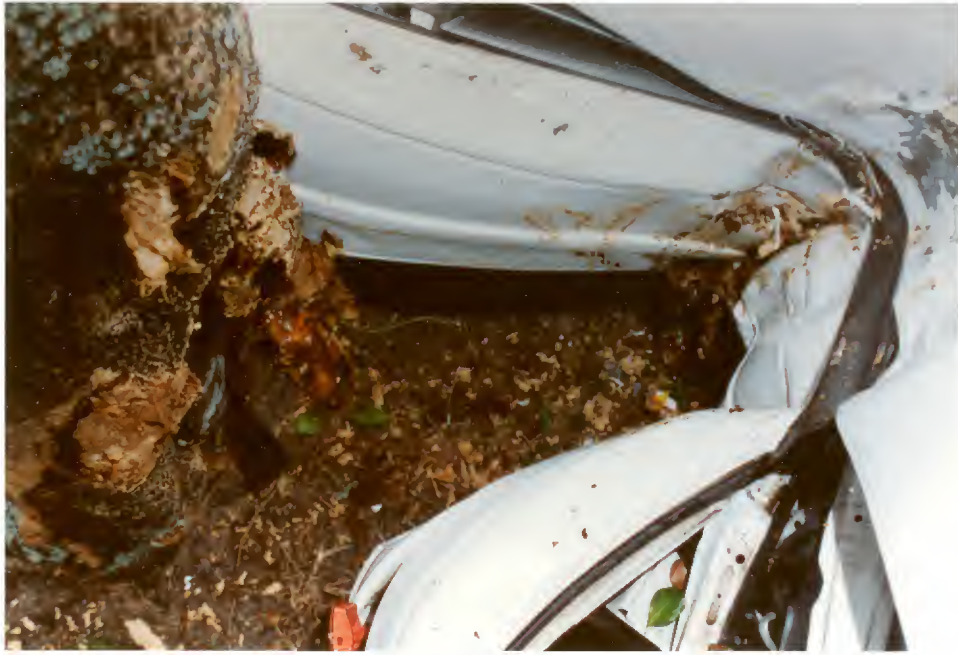
13. On-scene view of Vehicle #1's final rest position (FRP) showing the relative position of the vehicle's front bumper with the tree.

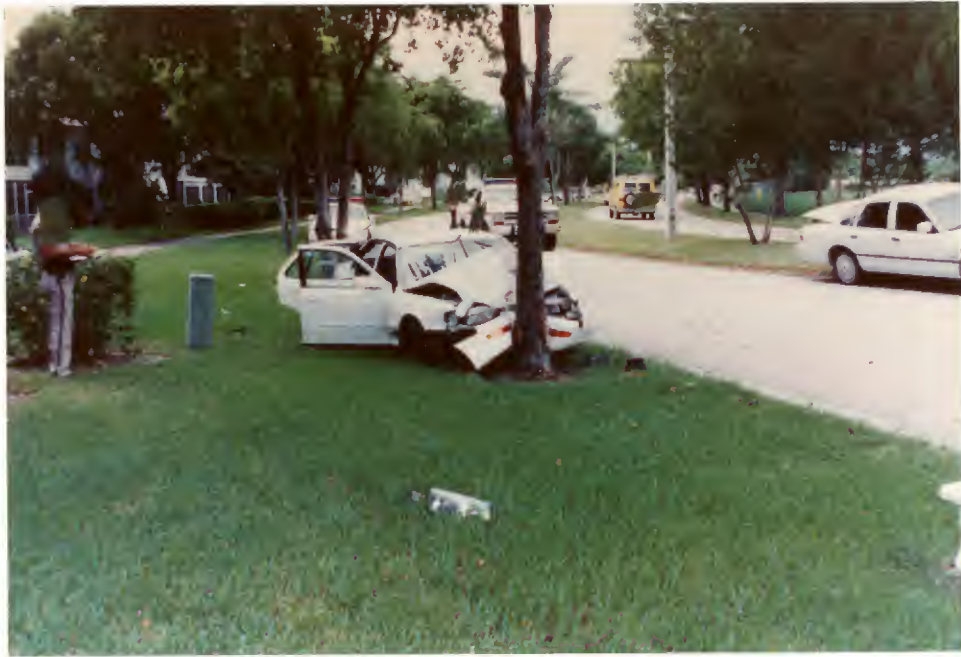
15. On-scene view of Vehicle #1's reverse trajectory.

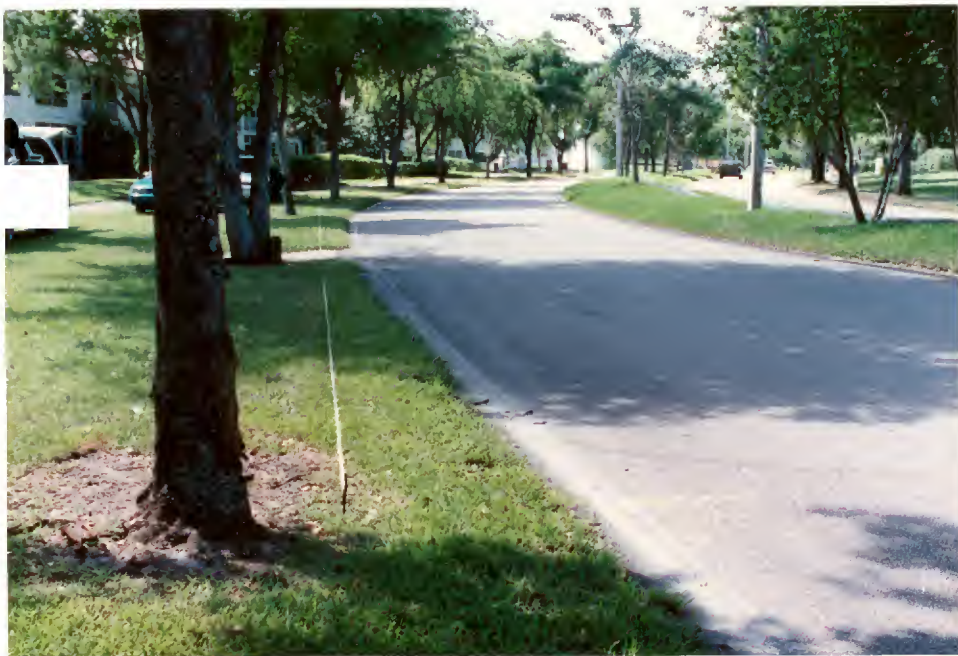
16. Reverse view of Vehicle #1's trajectory showing the second tree impact and area of the FRP.

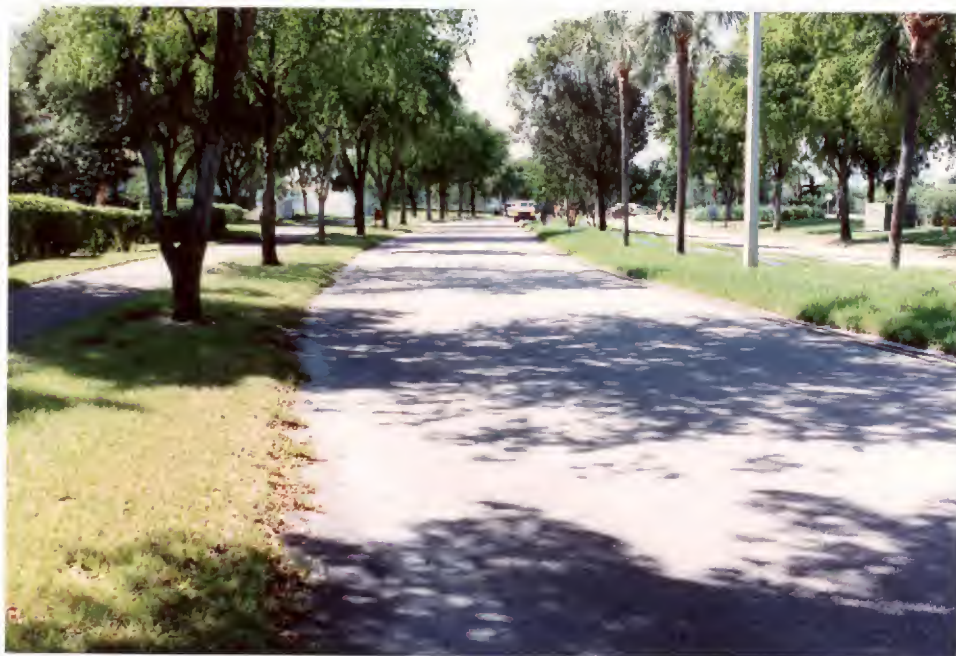
17. Reverse view of Vehicle #1's trajectory 46 m (150') west of the POI.

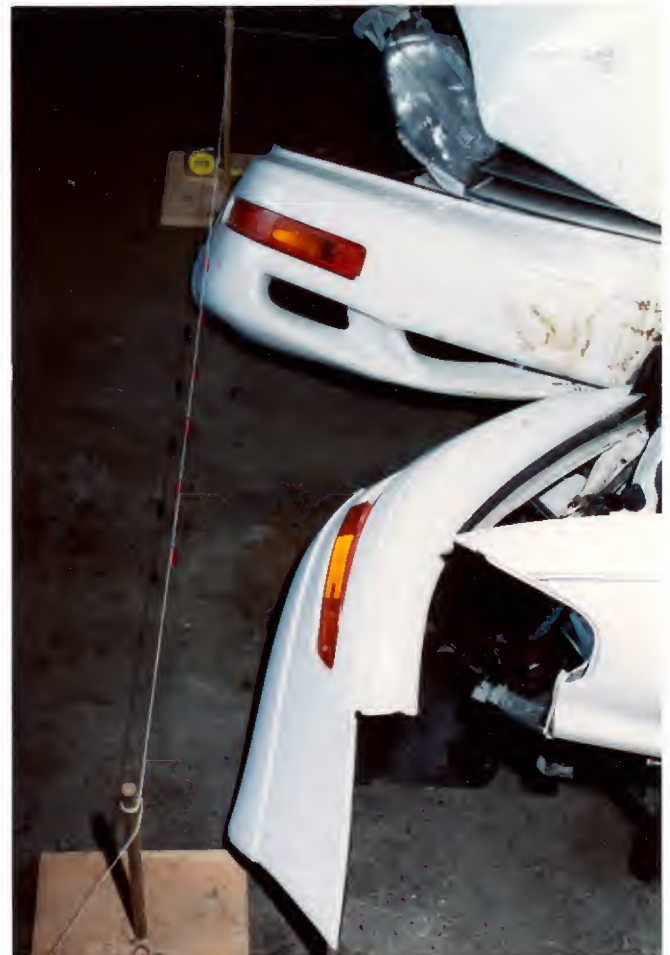
The second impact sequence involved the frontal plane of the vehicle and a 28.3 cm (11.1") diameter black olive tree. Direct contact began 7.6 cm (3.0") right of the vehicle centerline and displaced the bumper rearward 78.5 cm (30.9") at maximum crush. Components damaged in the crash included: the bumper; grille; hood; both front fenders; radiator; left and right headlight assemblies; windshield; and roof (refer to photographs #18-#32 on pages A-9 through A-16). The left side wheelbase was reduced in length by 13.0 cm (5.1") and the right side wheel base was reduced 2.0 cm (0.8").

20. Lateral view of the frontal plane taken from the left side of the vehicle showing the depth of crush.

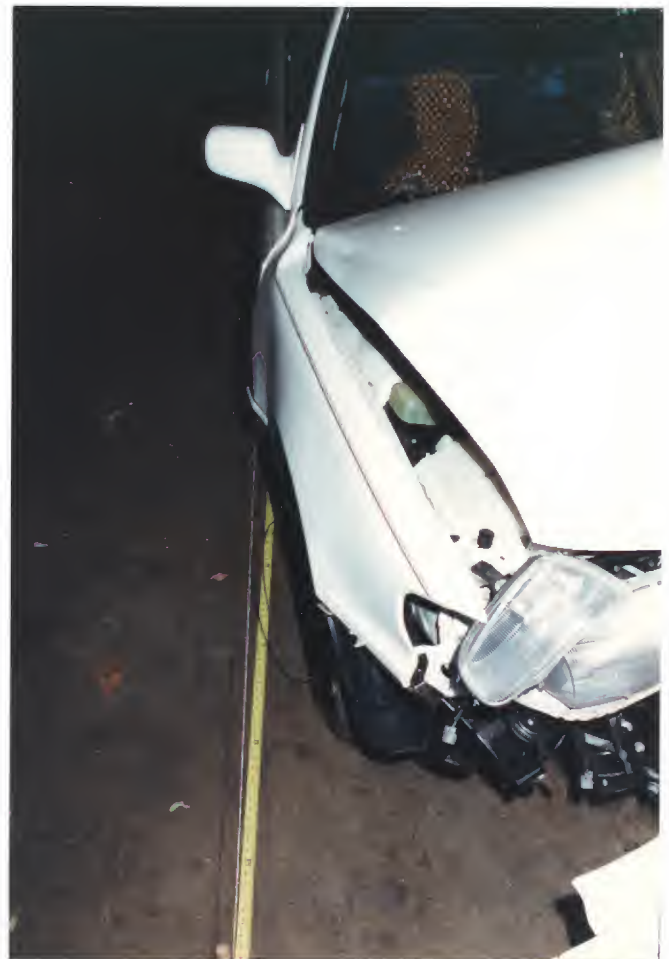
22. Longitudinal view of the right side plane taken from the front showing lateral displacement of the right front fender.

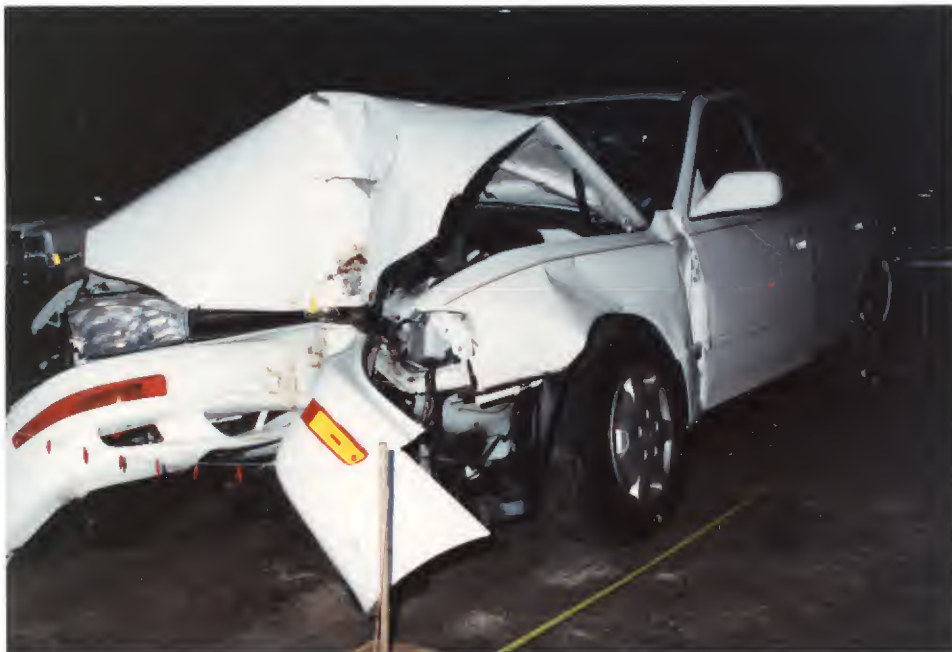
23. View of the left corner highlighting the frontal crush pattern.

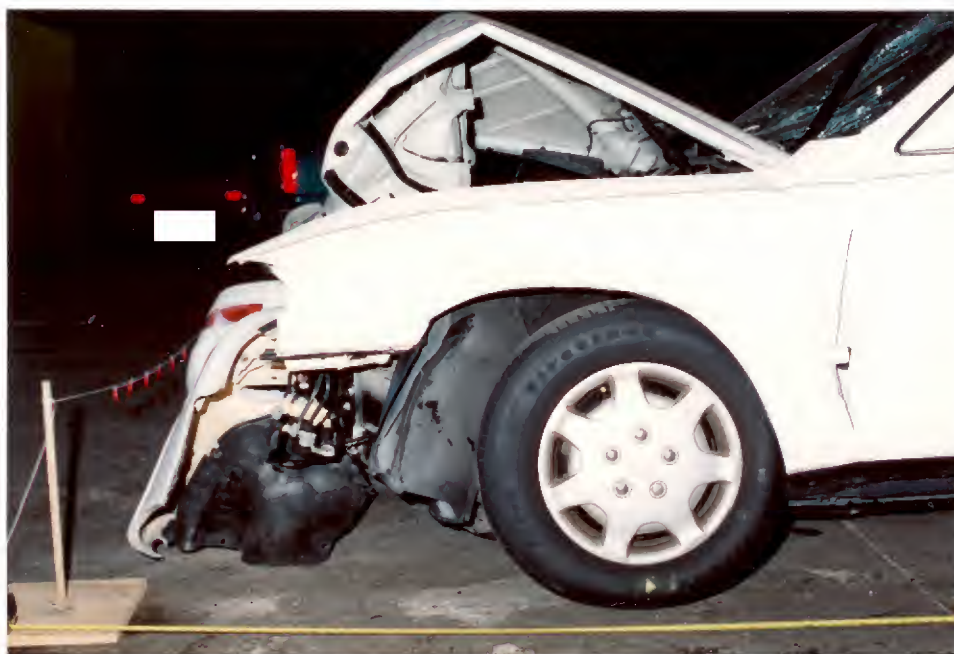
24. Lateral view of the left front fender.

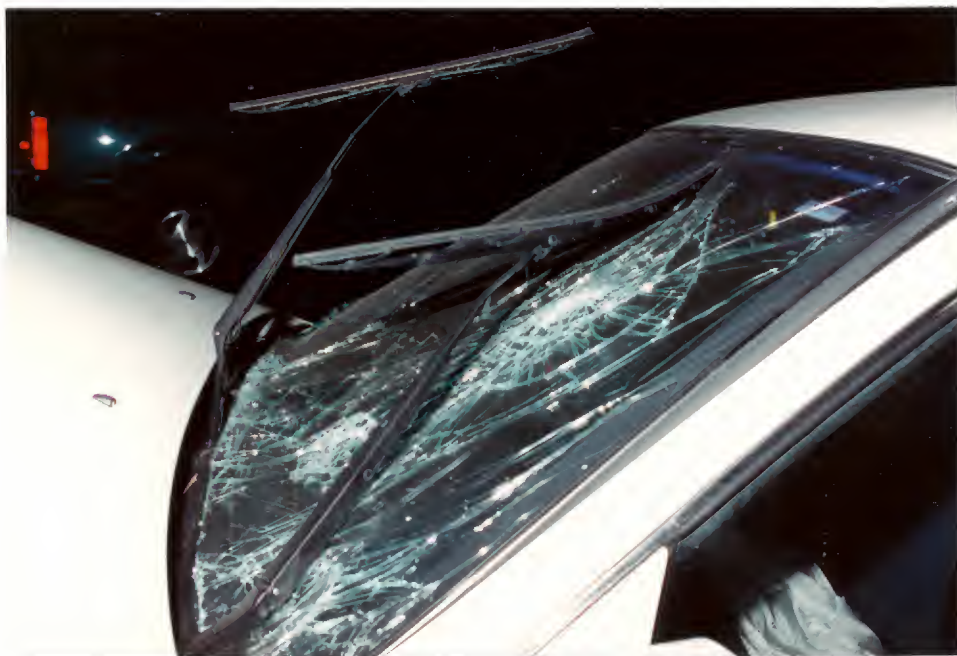
26. Lateral view of the windshield illustrating the position of the windshield wiper blades at the FRP.

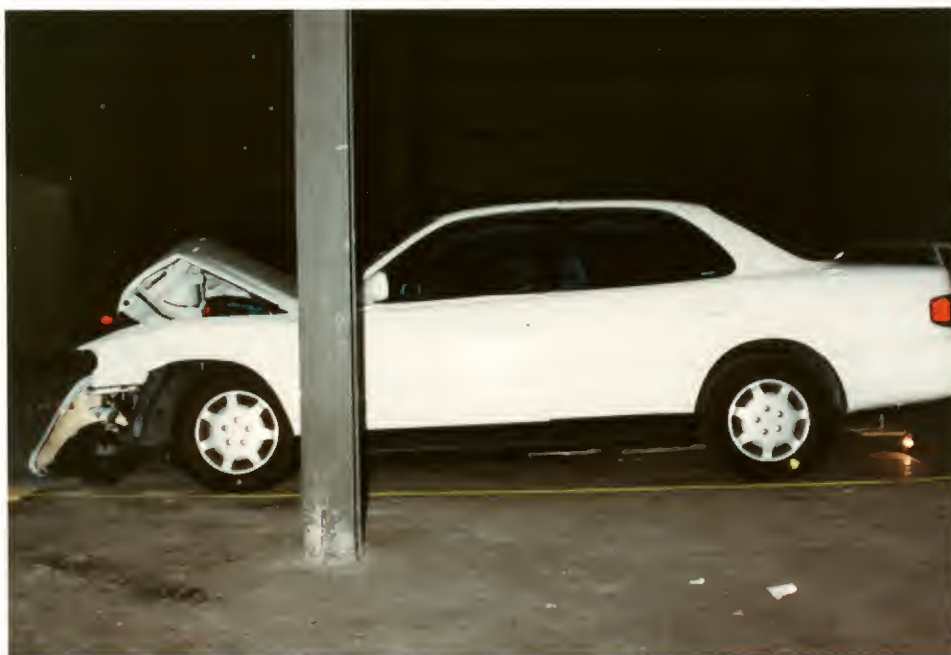
27. Overall view of the vehicle's left side plane.

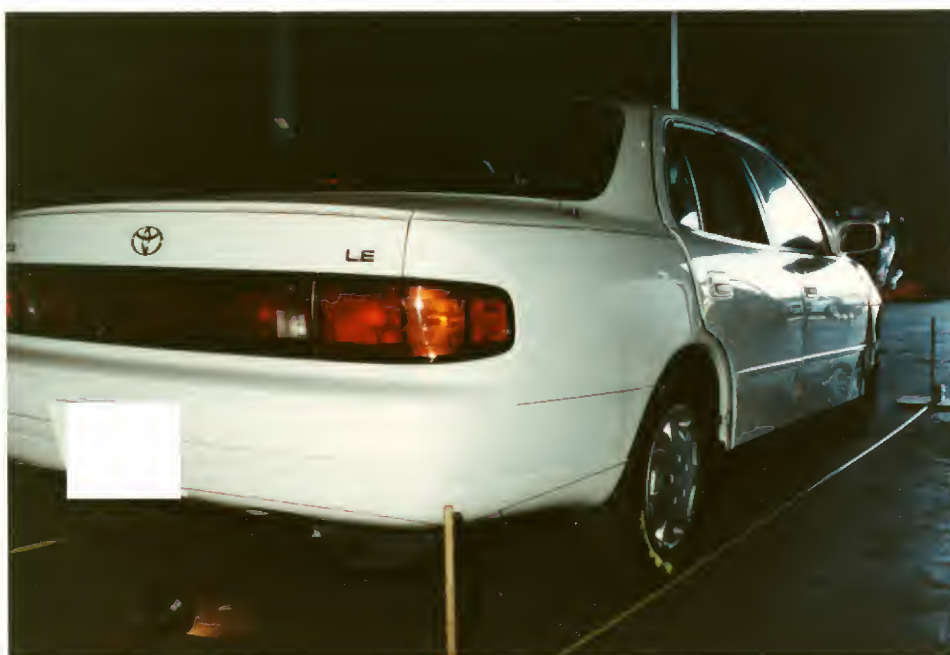
28. View of the right rear corner showing minor crush along the lower doors.

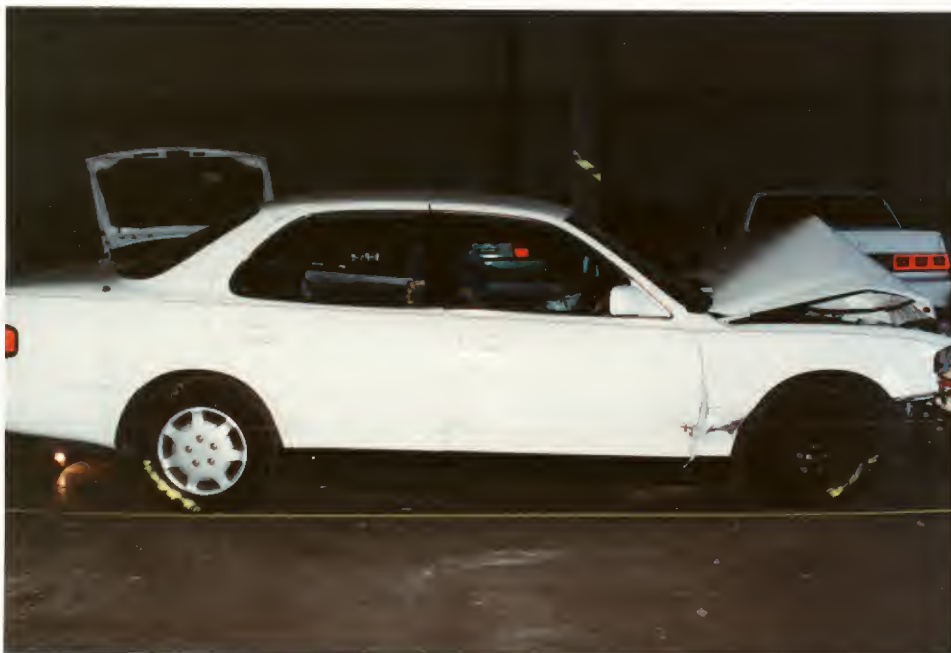
tree stump (impact #1) which began at the right front wheel and continued along the lower right side plane in a sideswipe pattern for a distance of 245.1 cm (96.5"). The contact height on the side of the vehicle measured [40.6 cm (16.0")] from the ground which was consistent with the height of the tree stump. The maximum crush for this impact was 3.8 cm (1.5") along the lower right front fender just behind the right front tire (refer to photographs #29, #30 on page A-15). Components damaged included: the right wheel and tire; the right front fender; and the right front and right rear door surfaces.

29. Overall view of the vehicle's right side plane illustrating the contact pattern which began at the right front tire and extended rearward to the rear wheel from the impact with the tree stump.

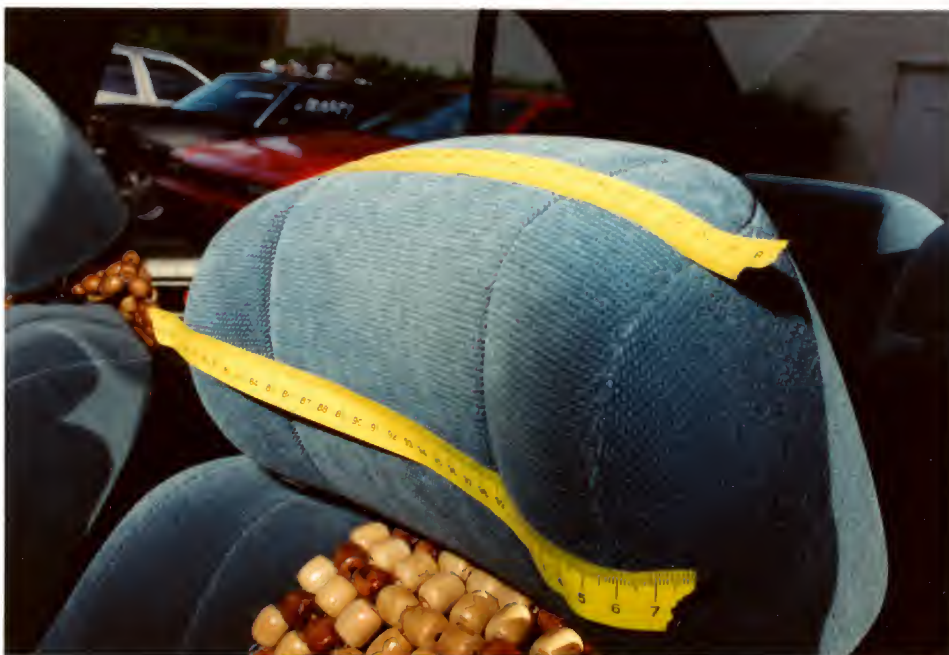
The driver rebounded rearward and contacted the seat back support and head rest. White hair fibers embedded in the fabric of the head rest was attributed to contact by the driver's head. Her upper torso then slumped forward and to the left with her head near the driver's door. Her left foot was on the floor directly in front of the seat and her right foot was in the vicinity of the accelerator pedal.

35. Close-up view of the driver's head restraint showing a light yellowish transfer from the driver's head/hair.

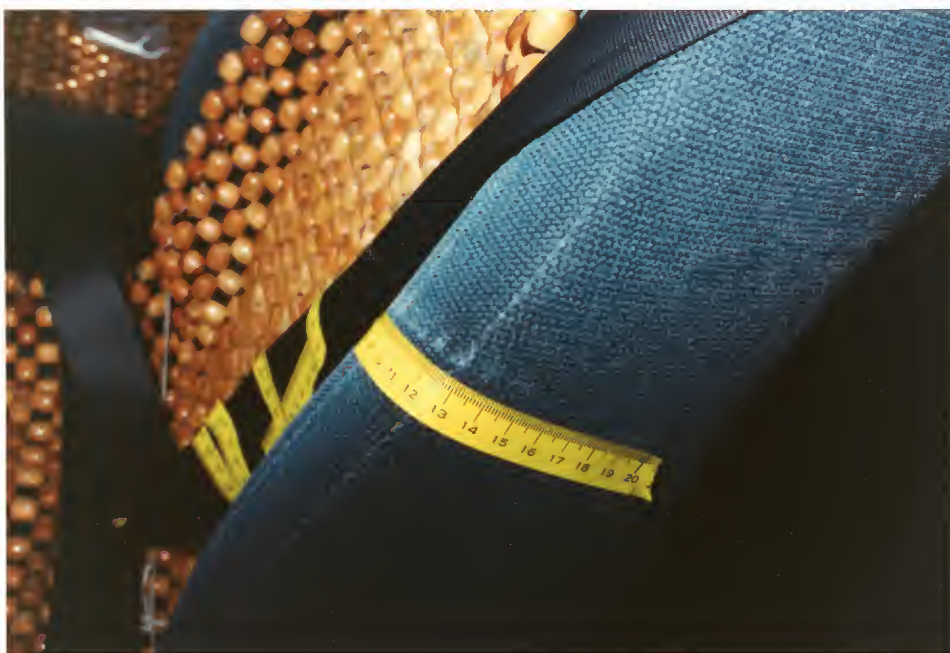
36. Close-up view of the abraded seat back fabric which was produced from the torso restraint belt during the impact with the second tree.

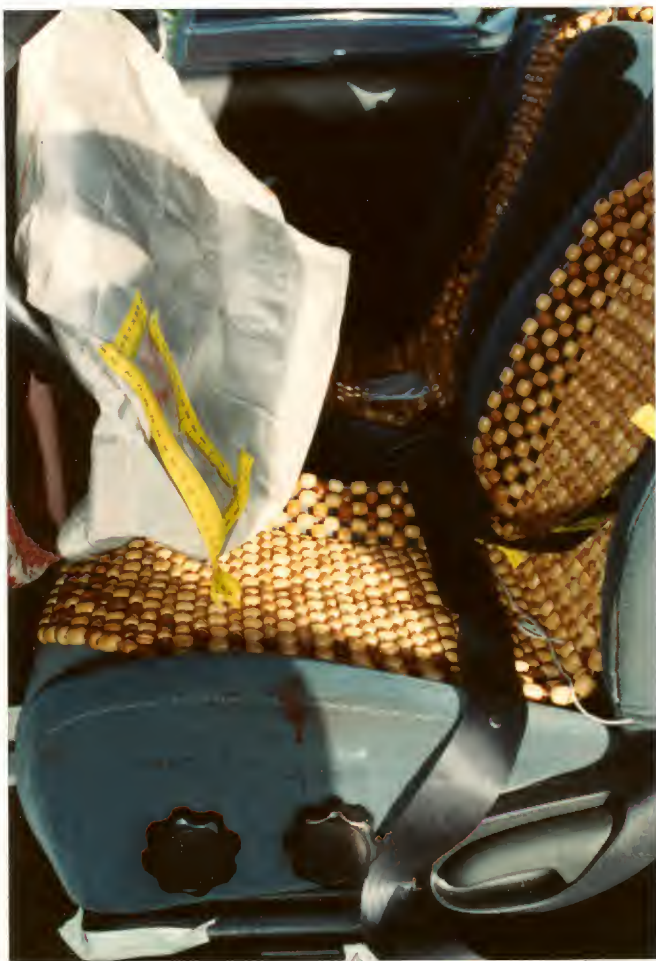
37. View of the seat placement at POI which was 15.5 cm (6.1") forward of the full rear adjustment position and 8.4 cm (3.3") rear of the full forward position.

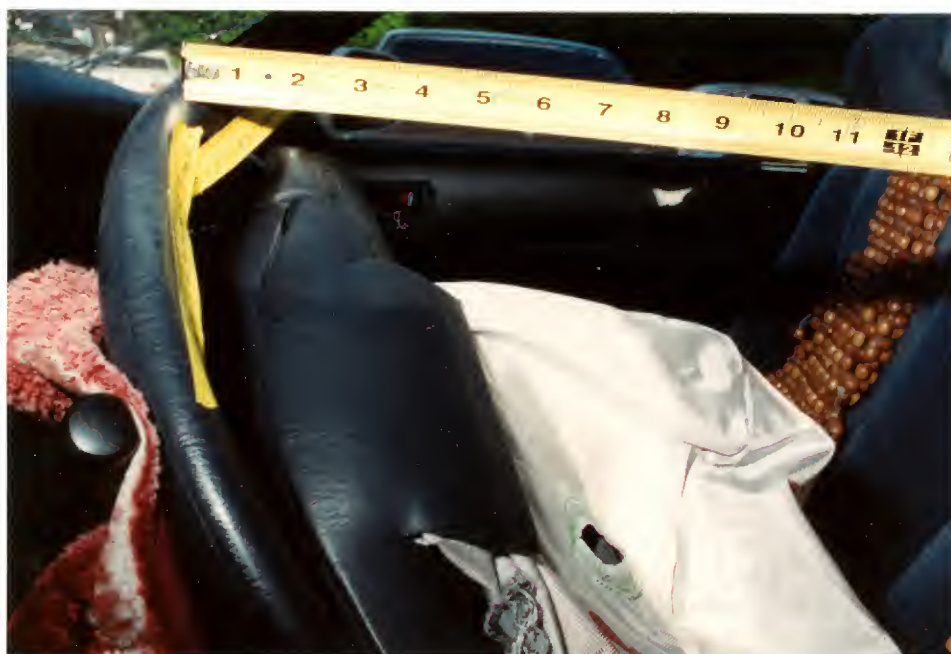
46. View of the top portion of the steering wheel which illustrates the forward displacement of the steering wheel rim.

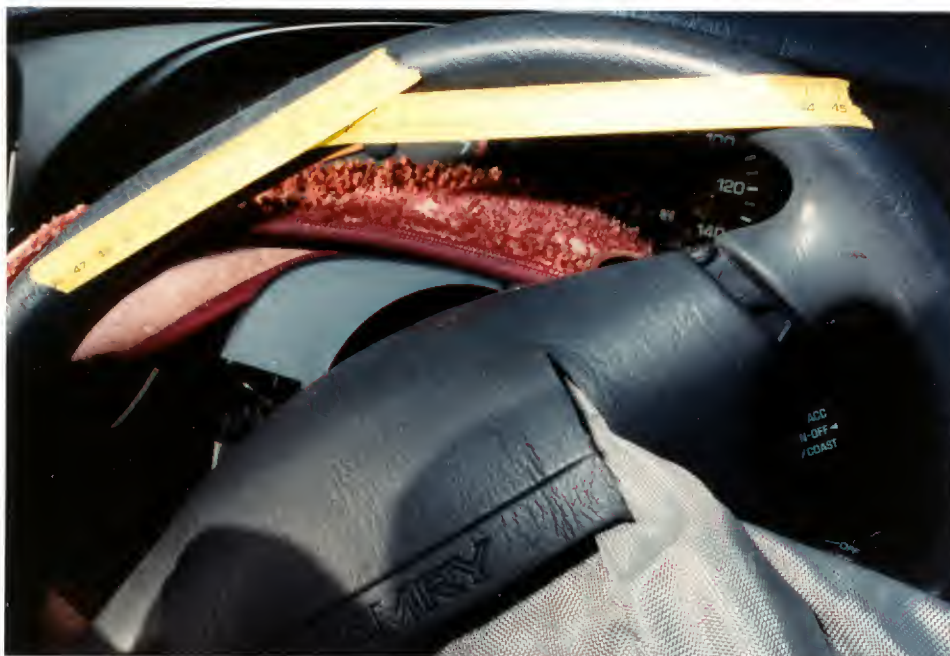
47. View of the top area of the steering wheel which illustrates driver contact and vertical displacement of the steering wheel rim.

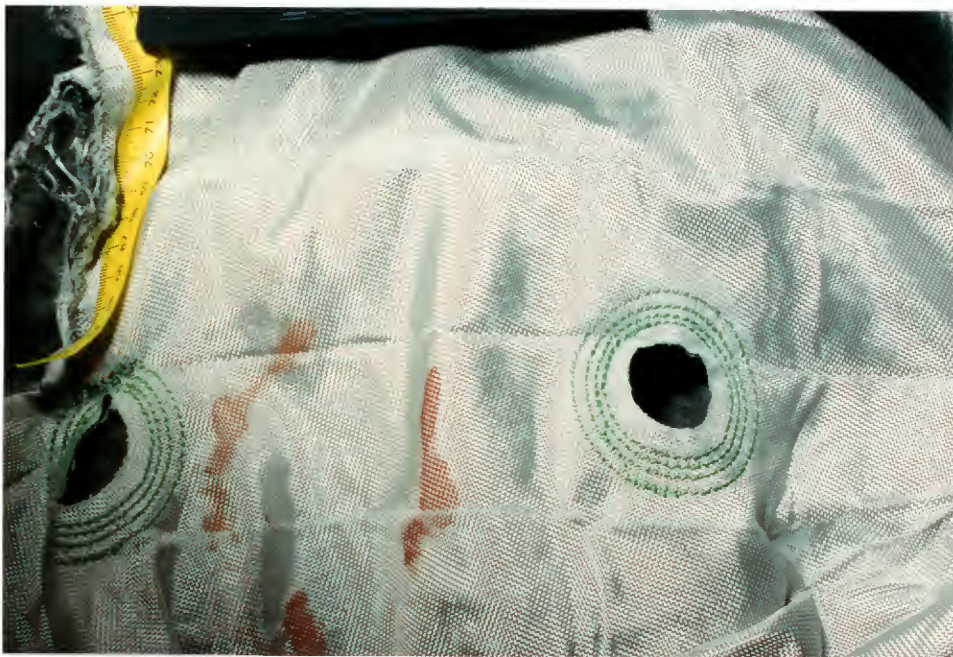
50. View of the two air bag vent ports located near the top portion of the air bag (instrument panel side of the bag).

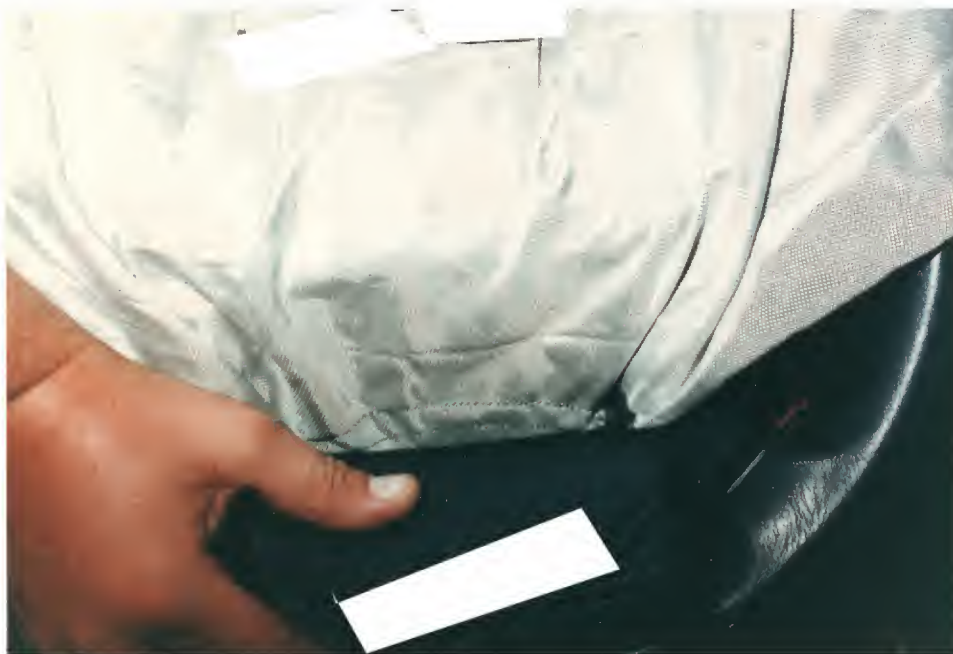
51. View of the inside surface of the lower air bag module cover flap showing a blue identification number applied during assembly ("0821-2").

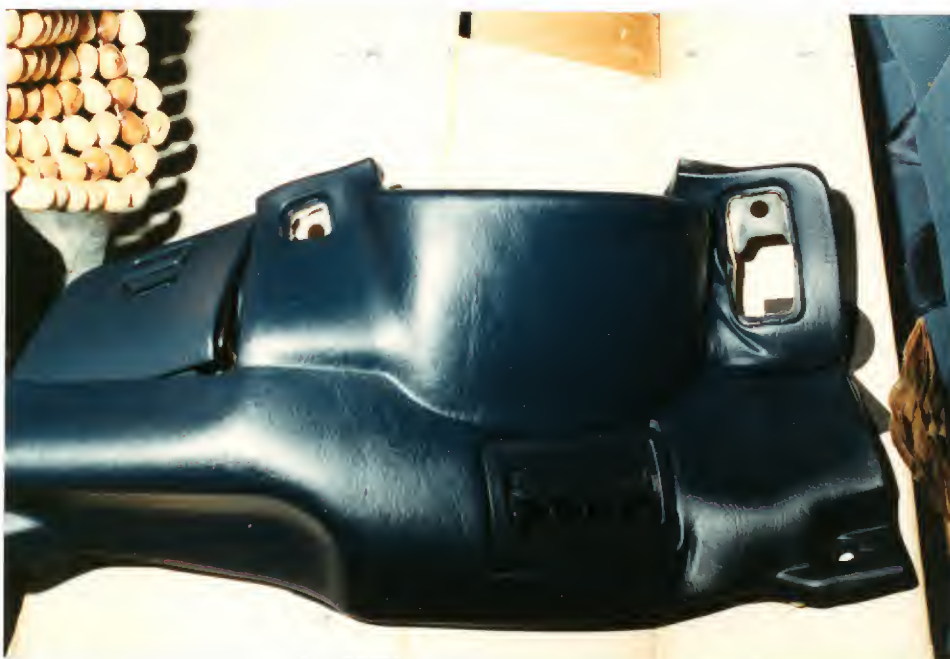
55. View of the knee bolster after removal from the lower instrument panel.

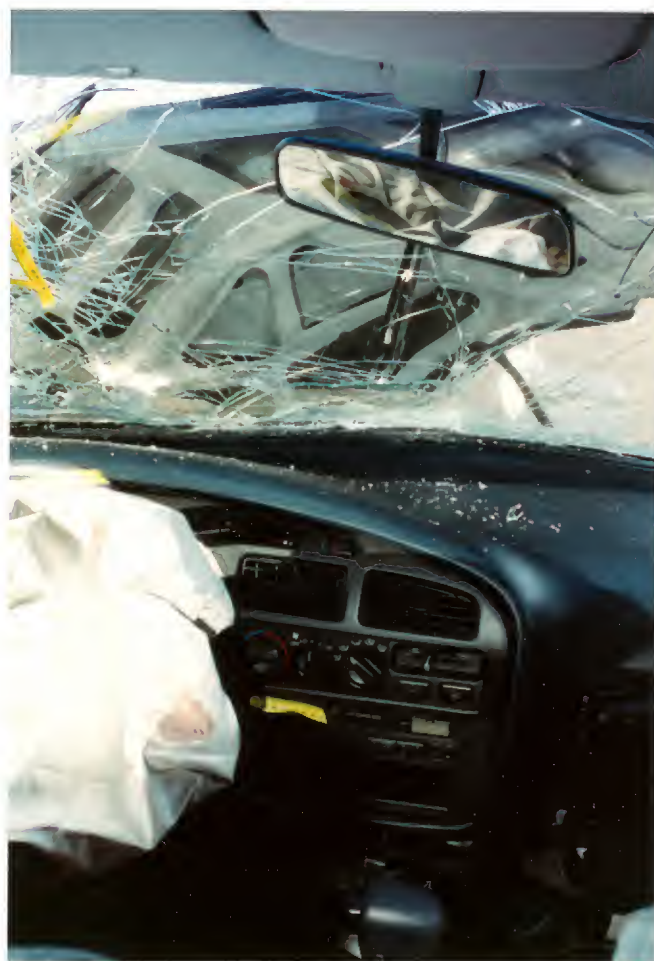
58. View of the center instrument panel and windshield.

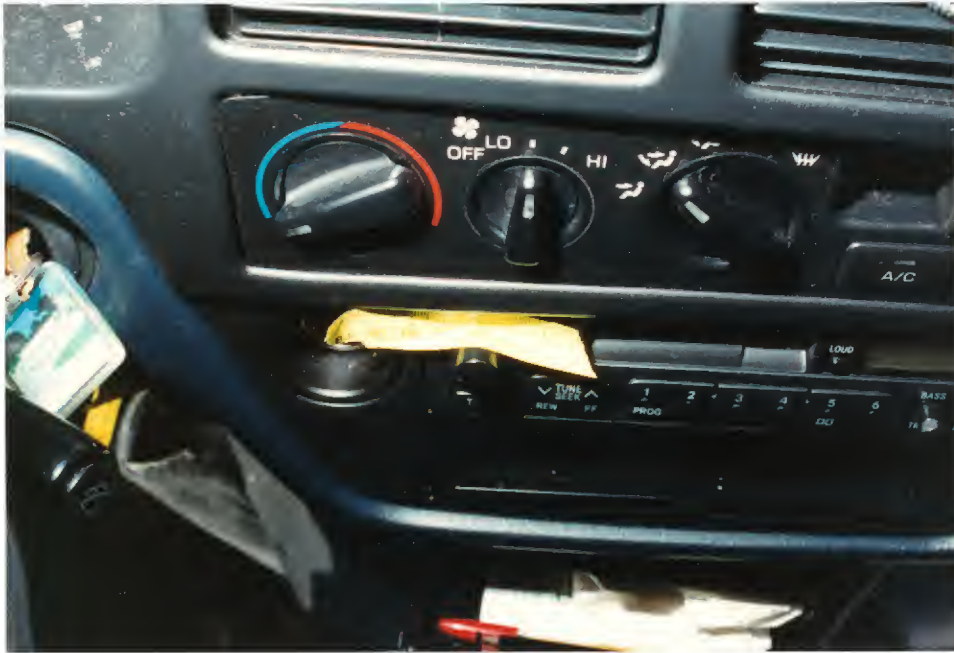
59. Close-up view of contact damage along the mid instrument panel.

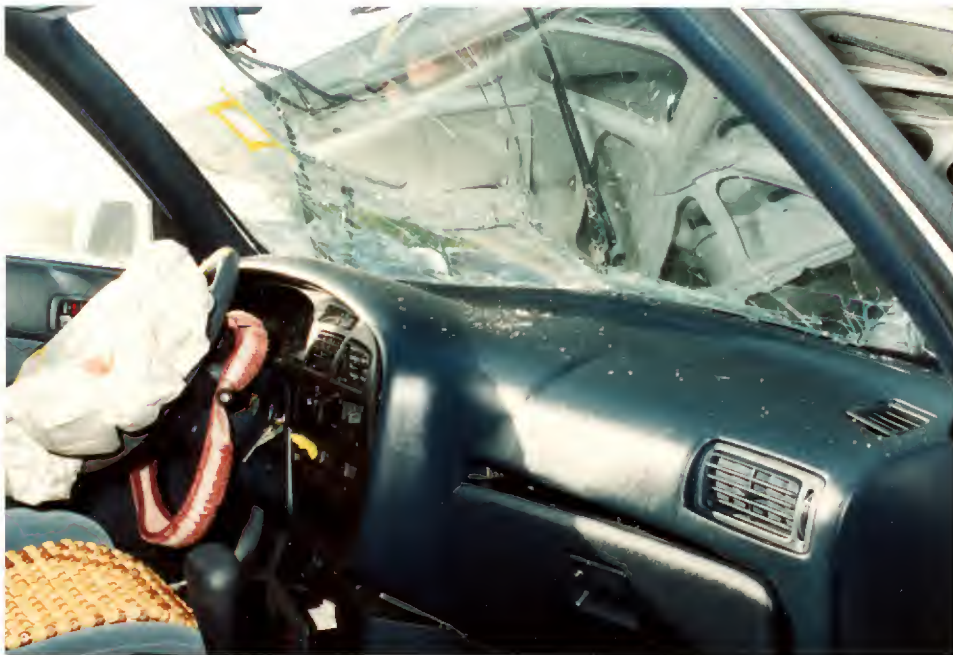
60. Angular view of the instrument panel taken from the right side of the vehicle.

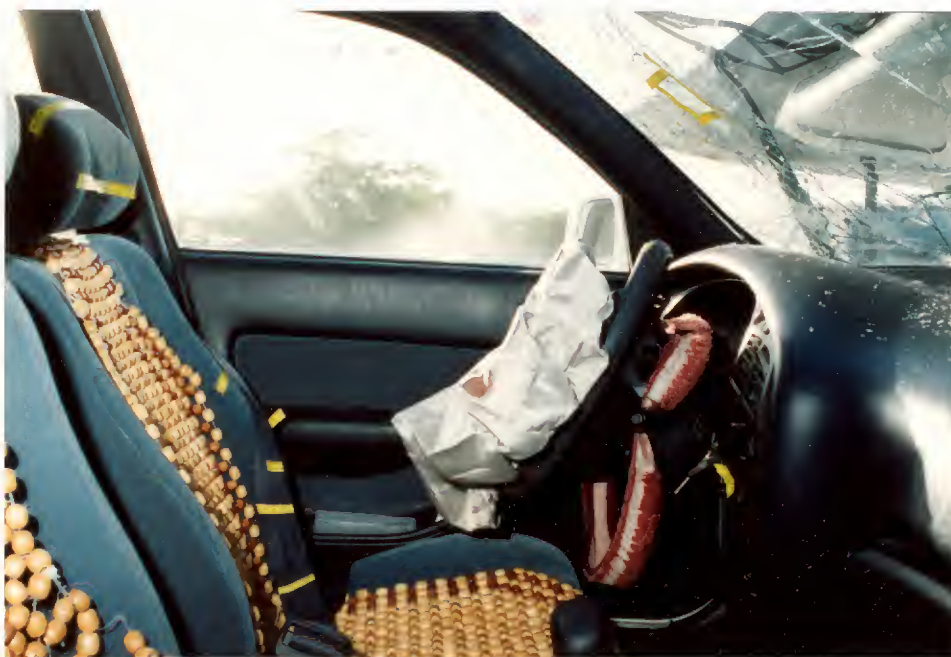
61. Lateral view of the driver's seating area with emphasis on the relative position of the driver's seat with the steering wheel at the time of air bag deployment.

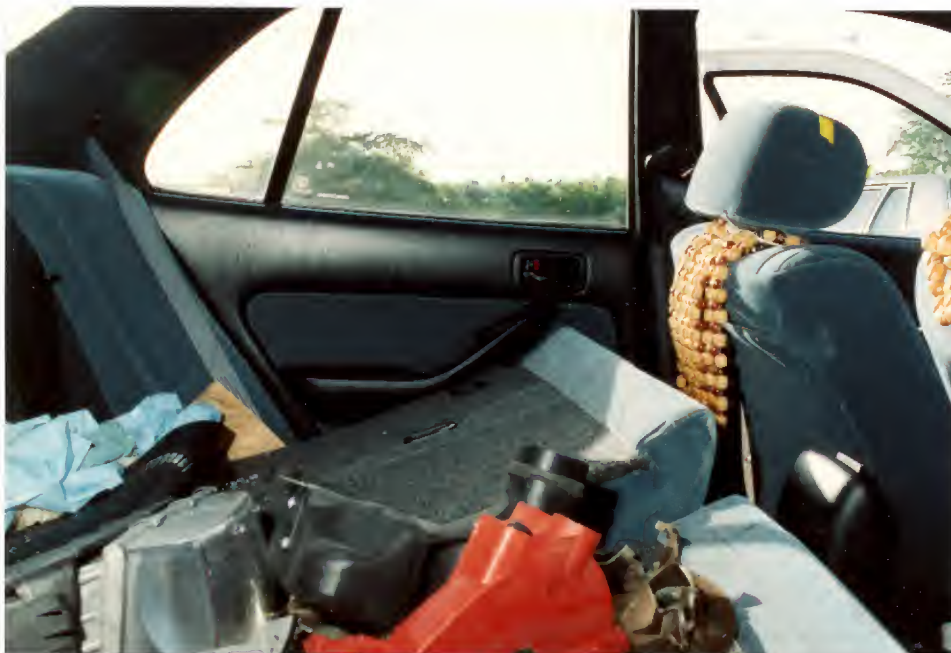
63. Lateral view of the rear seat area taken from the right side.
